Test Report

No.: CANEC23007324002

Sample Name: Quartz crystal

Model No.: seam3225/seam3215 32.768K

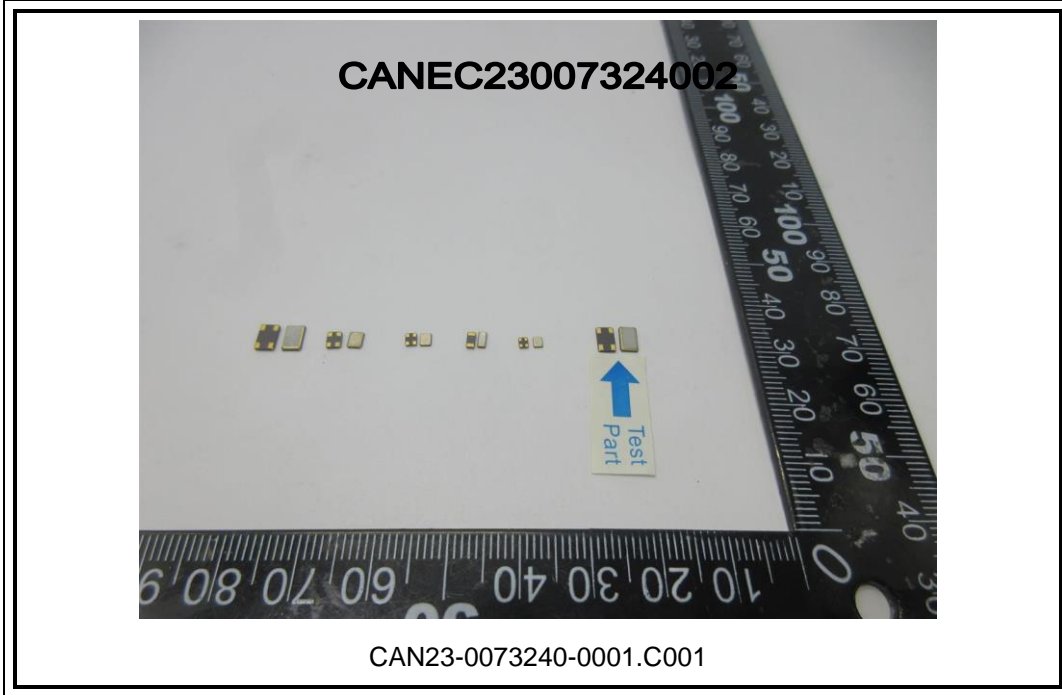
Sample Photo:

SN ID	Sample No.	SGS Sample ID	Description
SN1	A1	CAN23-0073240-0001.C001	"Quartz crystal"
